HPVA FINDINGS ON BLOTCHY CHERRY VENEER

3/14/2003

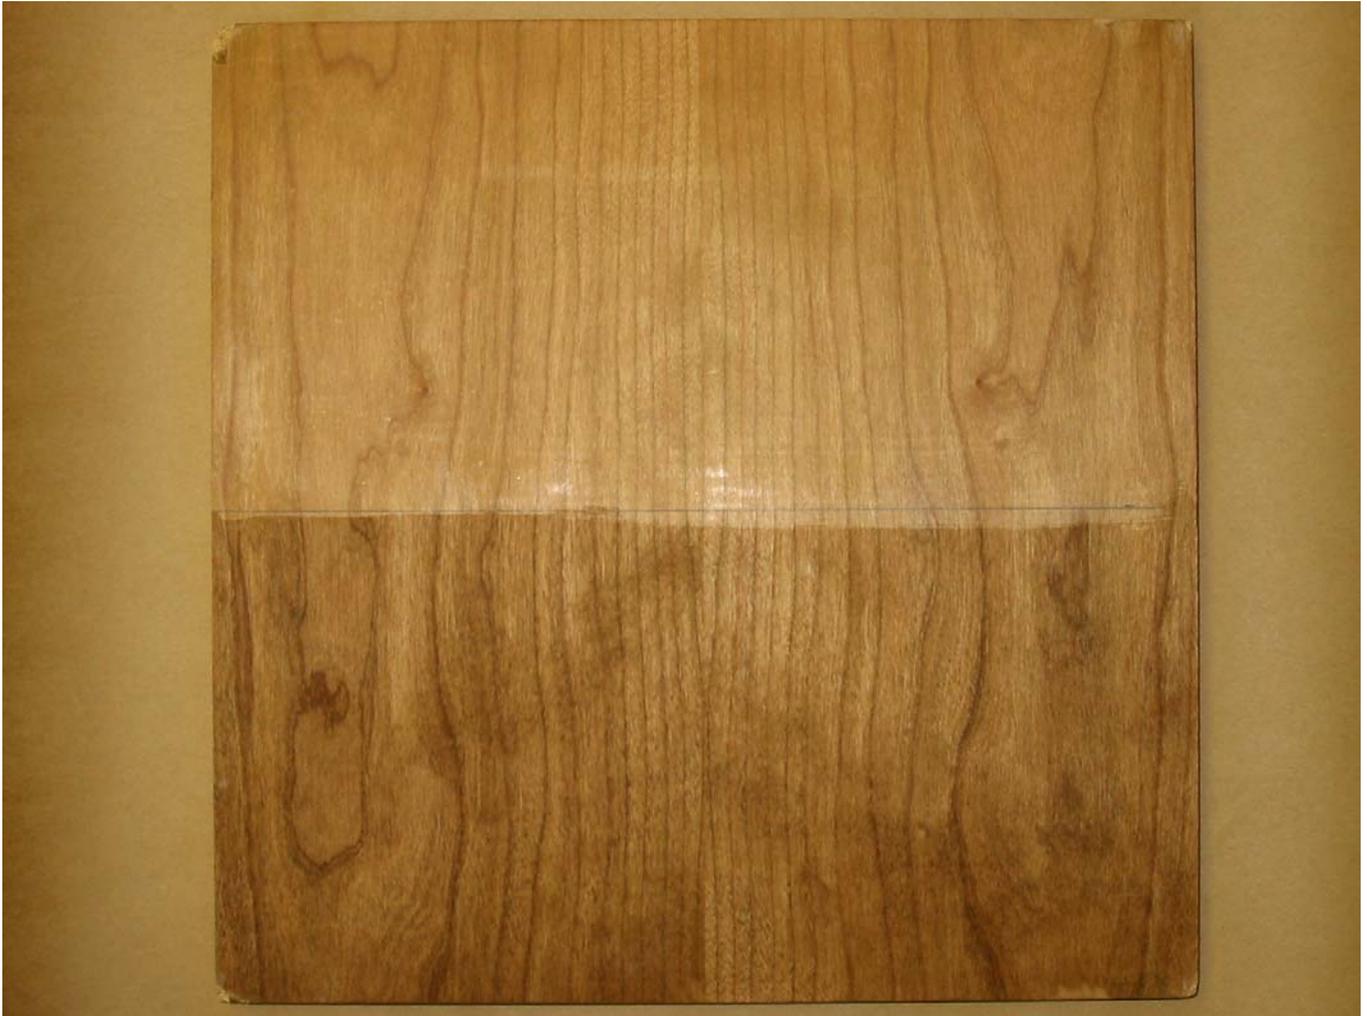
In the majority of raw cherry veneer and cherry veneered panel samples examined by HPVA, the uneven color appearance is believed to be due to figure. In such figured veneer, there are areas where wavy, open or end grain occurs at the veneer surface. This irregularity of the grain is sufficient, of itself, to cause differences in light reflection that appear as variations in color. A general characteristic of veneer of this type is that the dark areas often appear to become lighter, while lighter areas simultaneously appear to turn darker as the viewing angle is changed. If a finish stain is applied without first using a sealer, or washcoat, to partially fill areas with more open or end grain, such areas will tend to absorb more stain and actually become much darker in color, creating a severe blotchy effect. Proper sanding and the use of an initial sealer coat prior to staining is essential in order to minimize the blotchy effects of such natural figure in cherry. Popular industry opinion seems to be that figure in cherry has become, and will likely remain, more prevalent with newer sources of logs that are being used since most logging in the Allegheny National Forest was halted in 1999 due to environmentalist actions.

EXAMPLE OF BLOTCHY CHERRY INVOLVING FIGURE AND IMPROPER FINISHING

upper half of panel sealed and sanded before final finish coats – note color uniformity
lower half of panel unsealed & unsanded before final finish coats – note dark and blotchy color

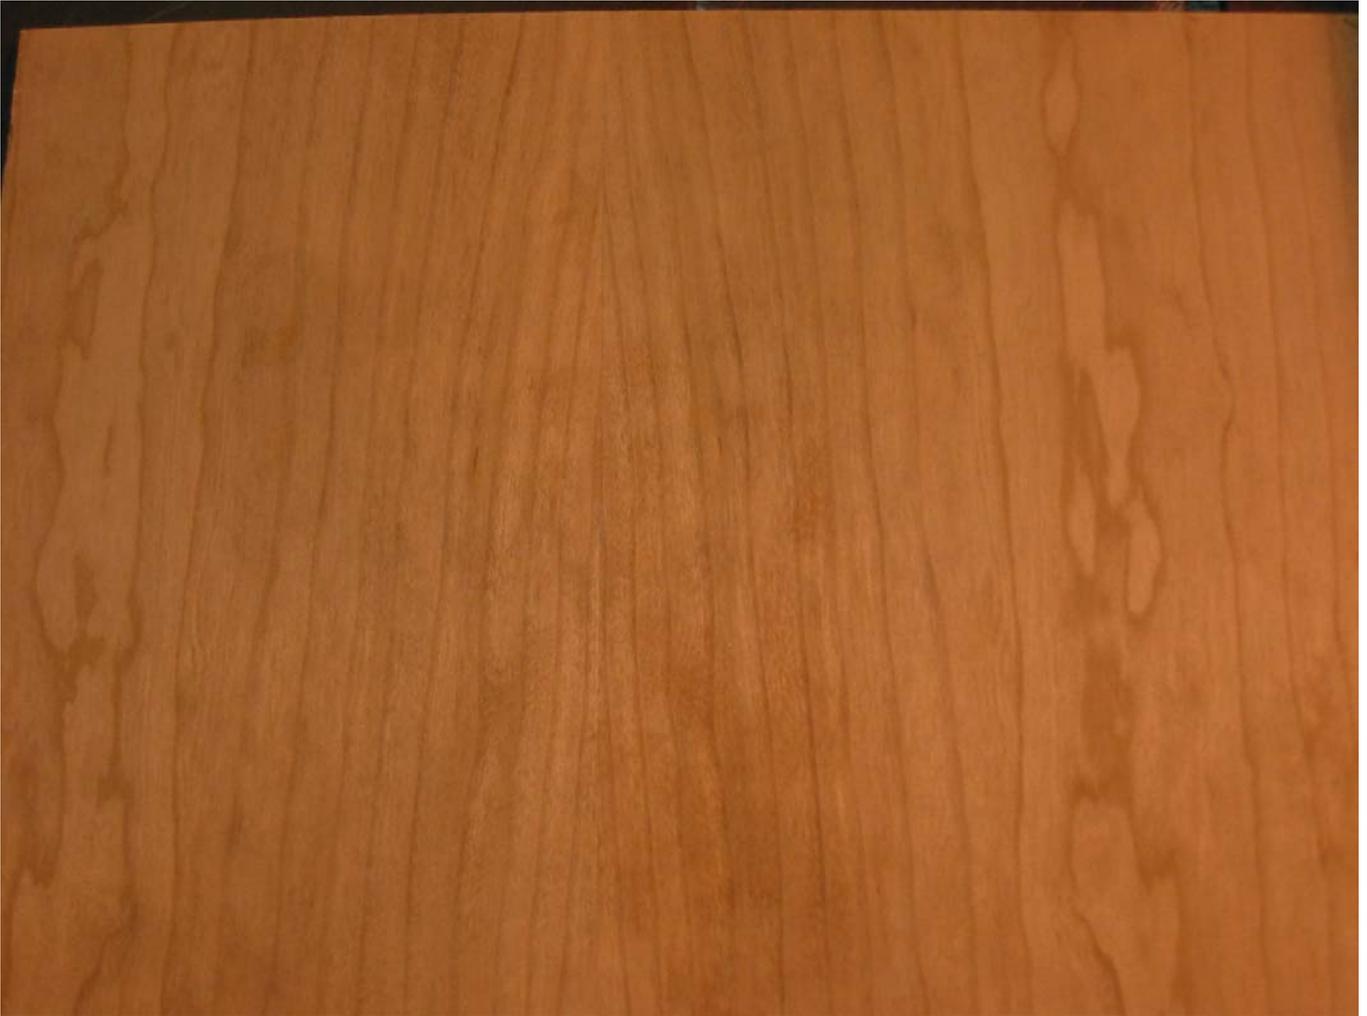
Two raw cherry plywood samples examined by HPVA exhibited a blotchy appearance of a different nature than that attributed to figure in other samples. In these samples, the darker areas had a somewhat shadow-like appearance, gray to charcoal or black in color, and did not appear to involve irregular grain. Darker areas tended to remain darker than surrounding areas with changes in the viewing angle.

Sanding of the panel surfaces failed to remove the discoloration, and microscopic examination of the cross-section confirmed that the discoloration extends through the veneer thickness. A sample of one of these panels was also sent to Mississippi State University for examination by Dr. Terry Amburgey. He performed a microscopic examination, and various chemical reaction tests. Based on the irregular pattern of distribution over the surface, the fact that the discoloration was concentrated in the wood rays, and that it could be eliminated by the application of dilute oxalic acid, but not by phosphoric acid, Dr. Amburgey concluded that the discoloration is most consistent with an enzymatic stain. He indicated that enzymatic stains are more common in sapwood, but can also occur in the heartwood of species such as cherry.

Dr. Amburgey also provided the following statements: He believes the veneer probably "came from a log stored under water spray for a prolonged period of time (several months). During this time enzyme stains could have occurred..." "High value veneer logs can be protected from enzymatic stains by rapid utilization and drying, log fumigation, or storing at low temperatures (refrigerate). These discolorations cannot be prevented by any of the anti-sapstain chemicals now on the market, but end coats (*on logs*) will retard their development." Also, during storage under water spray for a prolonged period of time, "depending on the water supply, the wood could have picked up enough iron to cause slight iron stain. Another possible source of iron stain is the hot water used to heat the logs prior to cutting veneer." It is possible that the water at the facility where the veneer was cut needs to be "treated periodically for iron removal."

EXAMPLE OF BLOTCHY CHERRY DUE TO STAIN

panel sample unsanded & unfinished
